Surface Analyses of Composites Exposed to the Space Environment on LDEF

J. J. MALLON, J. C. UHT, and C. S. HEMMINGER Mechanics and Materials Technology Center Technology Operations

31 August 1992

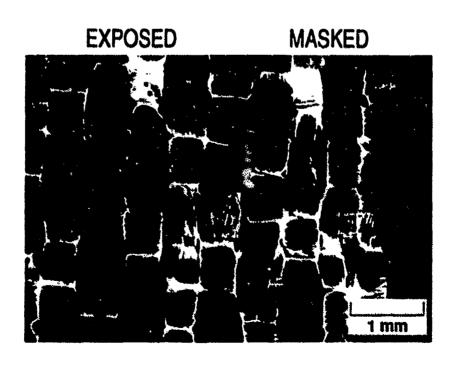
Figure 3 demonstrates that the matrix at the surface has been removed by atomic oxygen. A conductive coating is usually applied to composites before SEM examination because the polymeric resin at the surface is nonconductive. The quality of SEM images obtained from uncoated composite samples is generally poor because of surface charging. In this study, the degree of surface charging provides a qualitative measure of matrix erosion because the underlying carbon fibers are electrically conductive. In each case, we found that the exposed area of leading edge samples had little or no surface charging, indicating that the conductive carbon fibers were exposed. The trailing edge samples had extensive surface charging and were difficult to image because the nonconductive matrix had not been removed by erosion. In Figure 3, the lack of surface charging on the exposed area of L-A relative to the masked area and relative to T-A in the SEM chamber demonstrates that the nonconductive matrix at the surface of the leading edge samples was removed by atomic oxygen erosion.

Figure 3a. SEM micrograph (20X) of L-A surface showing exposed and masked areas.

Figure 3b. SEM micrograph (20X) of T-A surface showing exposed and masked areas.

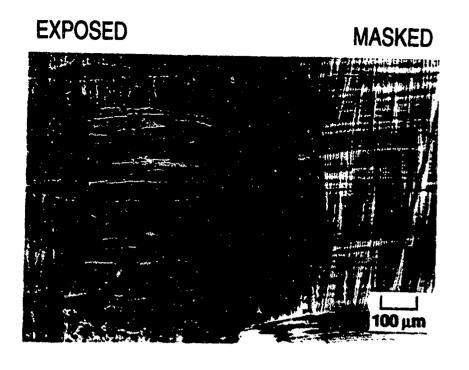
Figure 4. SEM micrograph (100X) of L-A surface showing exposed and masked areas.

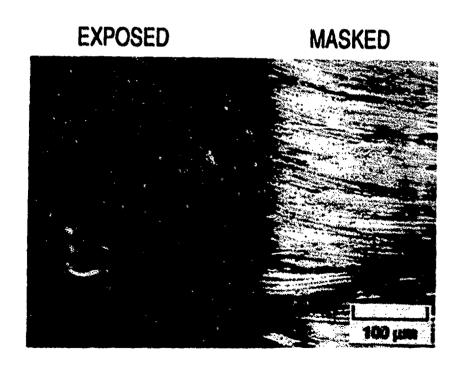
Figure 5. SEM micrograph (200X) of L-C surface showing exposed and masked areas.

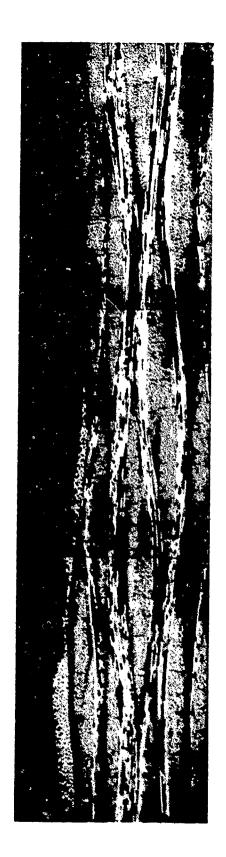
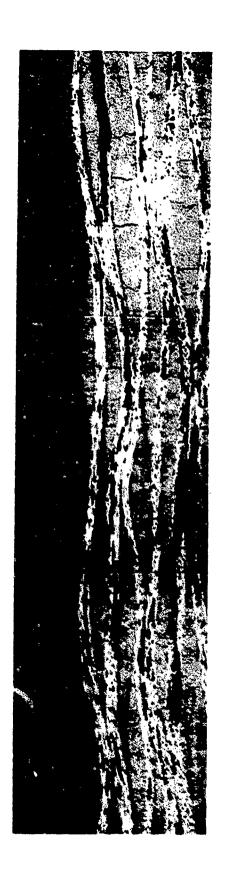
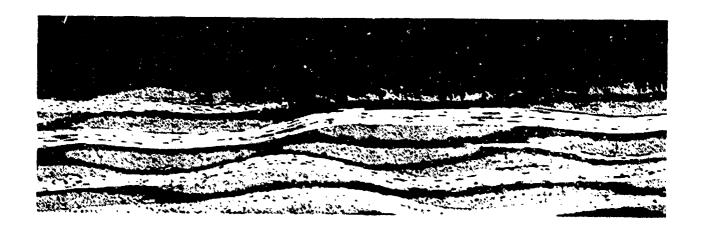
The erosion process results in a morphology on the leading edge samples that is best understood by examining both the SEM microgaphs of the surface and of the cross-sectioned samples. Figure 4 is a 100X SEM micrograph of the same area of L-A as shown in Figure 3a. showing details of the exposed area and of the masked area. The masked area was shielded from the effects of the space environment by the mounting hardware and shows the undamaged state of the composite before flight. Figure 5 is a similar 200X SEM micrograph of L-C showing exposed and masked areas. The exposed surface is characterized by large crevasses that have developed predominantly parallel to the long axis of the fibers. However, the surface SEM micrograph does not clearly elucidate the condition of the remaining exposed fibers. The cross section of the L-A surface shown in Figure 6 dramatically nighlights the "peak and valley" morphology associated with crevasse development on the exposed surface. Note that crevasses parallel to the cut of the cross section will not typically be seen. The area shown on the left side of the optical micrograph was masked and shows the relatively smooth preflight condition of the surface. Cross-section optical micrographs of the L-B and L-C samples, shown in Figures 7 and 8, show similar features to the micrograph of L-A. Sharp crevasses, predominantly parallel to the fibers, are also present on these surfaces, suggesting that the crevasse morphology is a general characteristic of the erosion process for this type of composite.

The addition of PPQ to the HA-43 matrix of composite C did not have an obvious effect on the erosion rate or pattern of erosion for L-C relative to L-A. L-B, however, was eroded to a lesser degree than the other two composites, as seen by comparing Figure 7 to Figures 6 and 8. Composite B was fabricated using PAA prepared in our laboratory, and also had the lowest resin content. Examination of L-B at high magnification reveals well-defined crevasses comparable to those on L-A and L-C in appearance, but on average significantly less enlarged. With so few samples, it can only be noted at this point that resin content and/or the details of resin composition/fabrication may play an important role in the overall composite erosion rate.

Figure 6. Optical micrograph (50X) of L-A cross section.

Figure 7. Optical micrograph (50X) of L-B cross section.

Figure 8. Optical micrograph (50X) of L-C cross section.

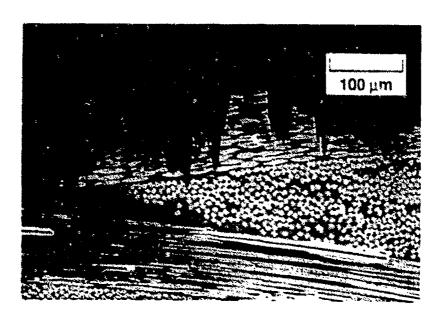
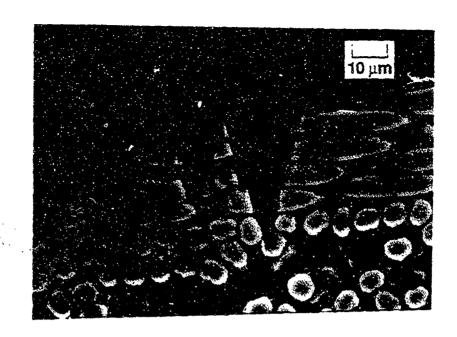
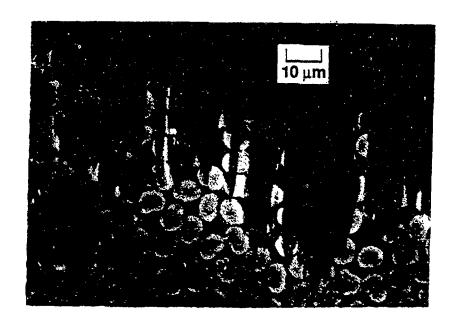
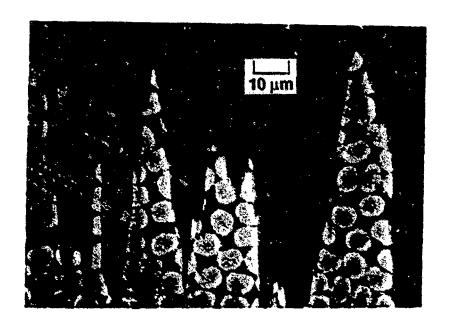
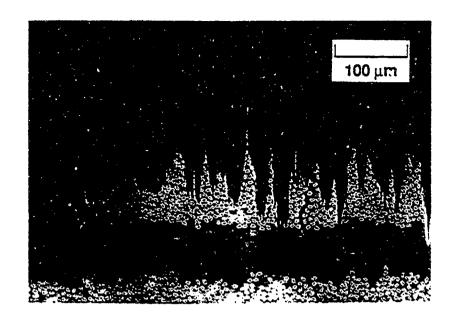
Higher magnification micrographs of the L-A, L-B, and L-C cross sections are shown in Figures 9-14. At this point it may be useful to distinguish between "cracks" and "crevasses". For our purposes, cracks were formed when two previously united sections of the composite became separated. There is no net loss of material during crack formation. The cracks were probably caused by thermal stresses during molding or during flight. In contrast, crevasses were formed when a section of the material, characterized by a sharp triangular cross section, was removed from the surface of the composite. The crevasses are completely absent on trailing edge sample surfaces, suggesting that they develop as a result of atomic oxygen erosion. Figure 13 shows a cross section of L-C, which contains both a surface crack and surface crevasses. The crack is narrow, uniform in width and longer in length than the wider, triangular crevasses. Note that the intersection of the crack with the surface did not cause a crevasse to form; in general, we found no correlation between the location of cracks and crevasses. There is no indication that the crevasses were initiated by surface cracks.

After examining a number of micrographs, we found that the leading edge samples had a number of features in common. All three of the samples, regardless of the matrix composition or fabrication details, exhibited a surface morphology dominated by crevasses with sharp triangular cross sections that ranged from $10~\mu m$ to $100~\mu m$ in depth. SEM examination of the surface shows that the crevasse direction was strongly correlated with the fiber direction. The majority of the crevasses developed parallel to the long fiber axis. The crevasses traversed both fibers and matrix, and most appeared to have relatively steep sides that met at a well-defined tip. No preferential removal of the matrix relative to the fibers (undercutting) was apparent along the

sides of the crevasse. Although the samples did contain macroscopic cracks, the cracks were not correlated with the crevasses and did not appear to initiate the formation of the crevasses.

Figure 9. SEM micrograph (200X) of L-A cross section.

Figure 10. SEM micrograph (1000X) of L-A cross section.

Figure 11. SEM micrograph (200X) of L-B cross section.

Figure 12. SEM micrograph (1000X) of L-B cross section.

Figure 13. SEM micrograph (200X) of L-C cross section.

Figure 14. SEM micrograph (1000X) of L-C cross section.

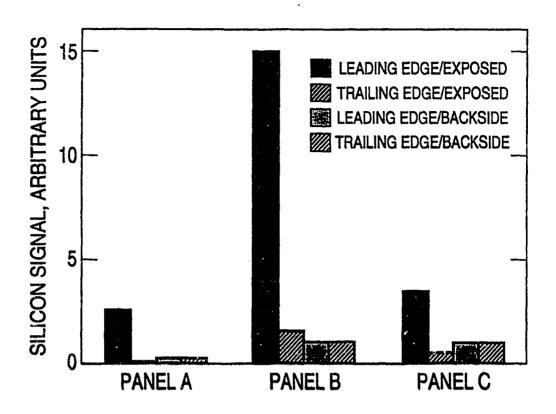
Figure 16. EDS relative silicon signals.
